# Evaluation Report

# 662

## Phoenix Rotary Harrow

# PHOENIX ROTARY HARROW

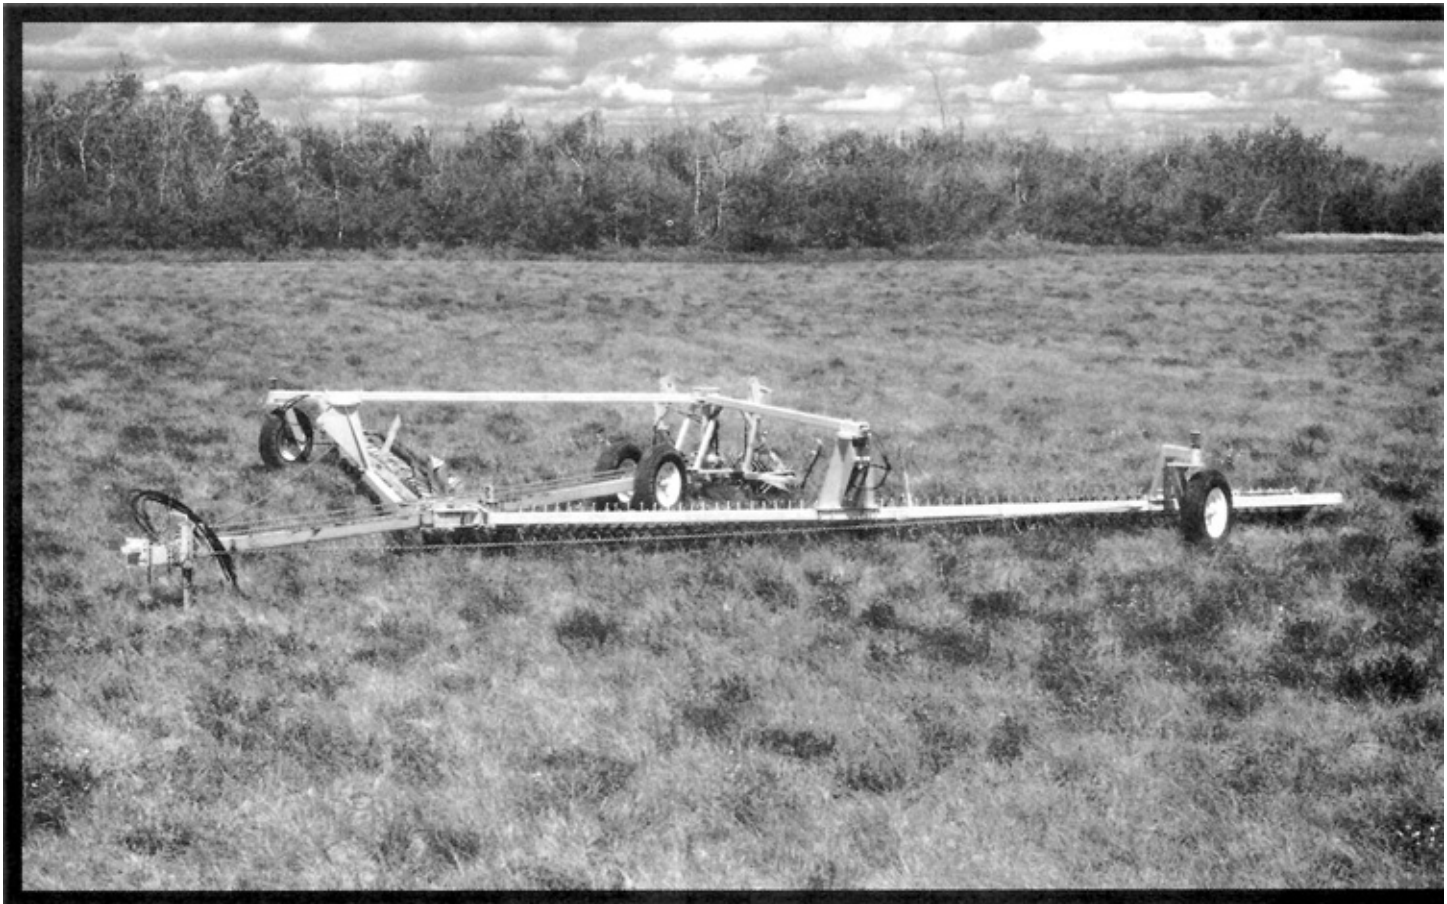
The Phoenix rotary harrow (FIGURE 1) is a light duty tillage machine having gangs of linked fingers or spokes that rotate over the field surface. The harrow can be used for levelling field surfaces before seeding or weeding summerfallow after tillage while maintaining trash on the field surface. It can also be used for shallow incorporation of pre-emergent chemical, or promoting weed growth for chem-fallow or continuous cropping practices. In some conditions, the rotary harrow can also be used to break up large amounts of dry trash.

The machine evaluated by PAMI was configured as described in the General Description, FIGURE 1, and Specifications section of this report. The manufacturer may have produced different versions of this machine either before or after the PAMI tests. Therefore, when using this report, check to ensure the machine being considered is the same as the one evaluated in this report. If differences are found, PAMI or the manufacturer may be contacted to determine the effect of the changes on performance.

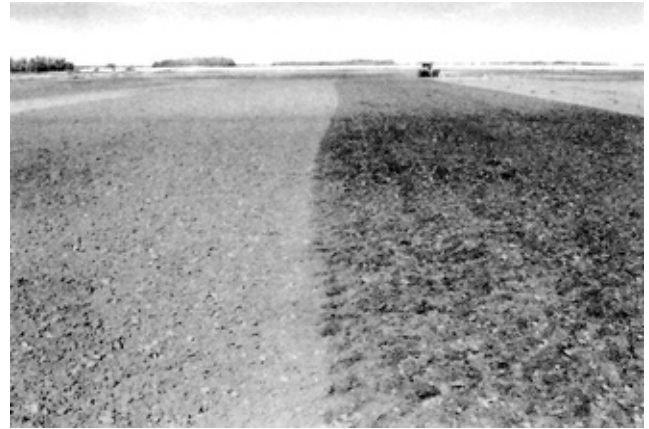
The soil finish in fallow conditions was usually very level. The rear centre harrow, when properly adjusted, was effective in levelling the ridge left between the main harrow sections. In dry and moist soil conditions while using harrow angles of 35° or more, the surface was fine, with most trash lying loosely on the soil surface (FIGURE 2).

FIGURE 2. Field Surface in Summerfallow.

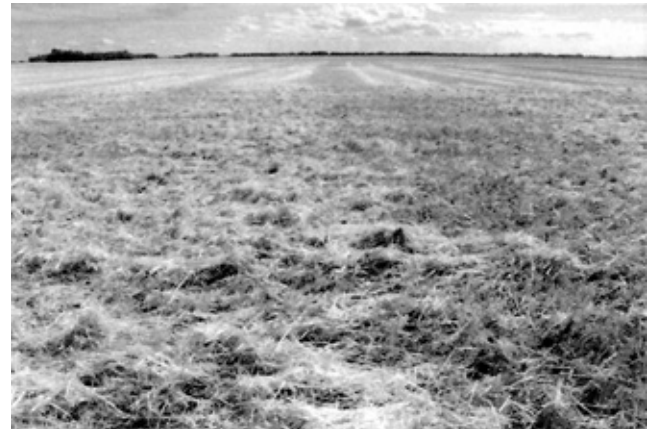
In wheat stubble, when set at the 45° harrow angle, chopped straw left by the combine was moved about 3 ft (0.9 m) when operated perpendicular to the direction of the previous combine operation. Harrowing the field a second time in the same direction moved the straw approximately another 4 ft (1.2 m) (FIGURE 3). In extremely heavy trash conditions, the trash was left evenly on the field surface after one pass. However, a second pass resulted in small straw bunches on the field surface (FIGURE 4).

FIGURE 3. Straw Spread (After Two Passes).

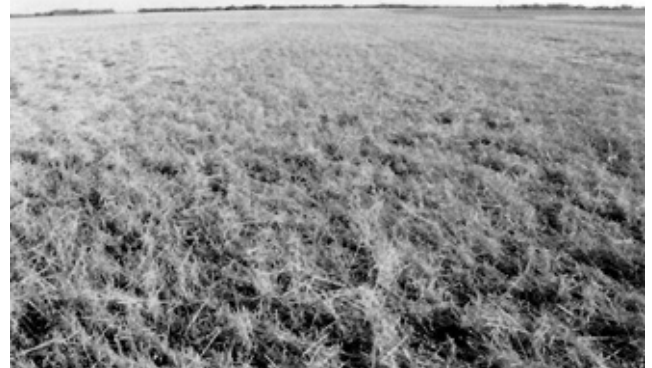
FIGURE 4. Hail Damaged Wheat (Second Pass).

The rotary harrow was capable of clearing large amounts of dry straw or weeds. While operating in a hail damaged wheat crop, at a 40° angle, most of the straw was broken from the soil or stubble and left lying loosely on the field surface. More stubble was uprooted by a second operation. The second pass however, created a slightly bunched appearance on the field surface (FIGURE 4).

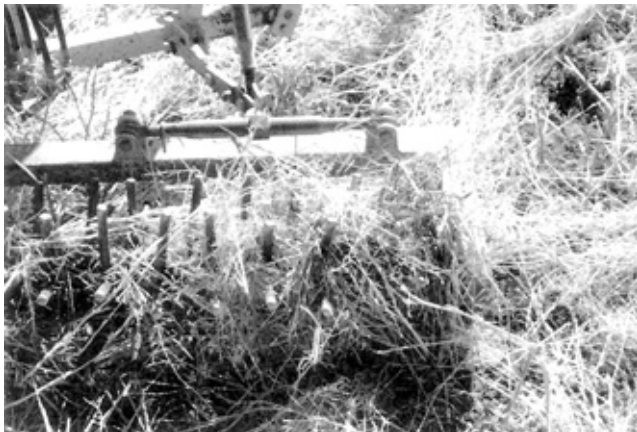
Green weeds and tough straw wrapped tightly at the three trailing tine bearing locations (FIGURE 5). The wrapped material required frequent removal in weedy or tough straw conditions. It is recommended that the manufacturer consider modifications to the tine bearing mounts to prevent wrapping of tough material.

FIGURE 5. Tough Material Wrapped at Bearings.

1. Modifying the tine bearing mounts to prevent wrapping of tough material.
2. Simplifying the method of placing the rotary harrow into transport.
3. Providing permanent marks on the hitch pole and chains for more convenient harrow angle adjustment.
4. Providing a transport lock for the centre rear tine section, and a lock for the wing section tines when raised in field position.
5. Providing a hitch safety chain, a slow moving vehicle sign or bracket, and safety information in the operator's manual.
6. Modifying the hitch link to provide vertical movement of the rotary harrow.

1. An anti-fouling device is available as optional equipment. A new bearing configuration that prevents wrapping is provided on new machines.
2. We are modifying the transport system. Other models are easier to put into transport.
3. Future machines will have permanent marks. We presently locate the angle positions with the owner at the time of purchase.
4. Transport locks will be provided.
5. A hitch safety chain and SMV sign will be provided. The operator's manual will have safety information added.
6. We will enlarge the hitch pin hole to allow this.
